INDOOR AIR QUALITY ASSESSMENT

**Board of Registration in Medicine
200 Harvard Mill Square, Suite 330
Wakefield, Massachusetts**

Prepared by:
Massachusetts Department of Public Health
Bureau of Environmental Health
Indoor Air Quality Program
July 2019

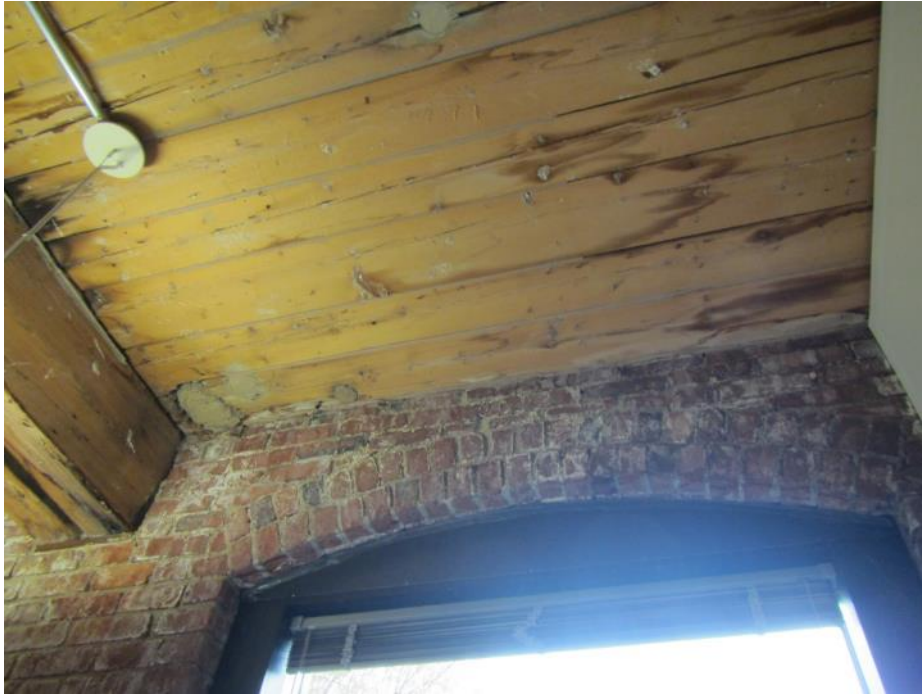
Picture 1

Occupants near a window outside open cubicle area 322 reported that there is an active water leak in this area (Picture 1). Property managers were aware of this leak and have been seeking remedies. Chronic water leaks can cause microbial colonization of porous building materials if the porous materials are not dried properly.

Area of reported active water leak

12. Repair any known active water leaks. Monitor any areas of suspected water infiltration and ensure porous building materials are dried within 24-48 hours. Discard any water-damaged porous materials that have not been properly dried.

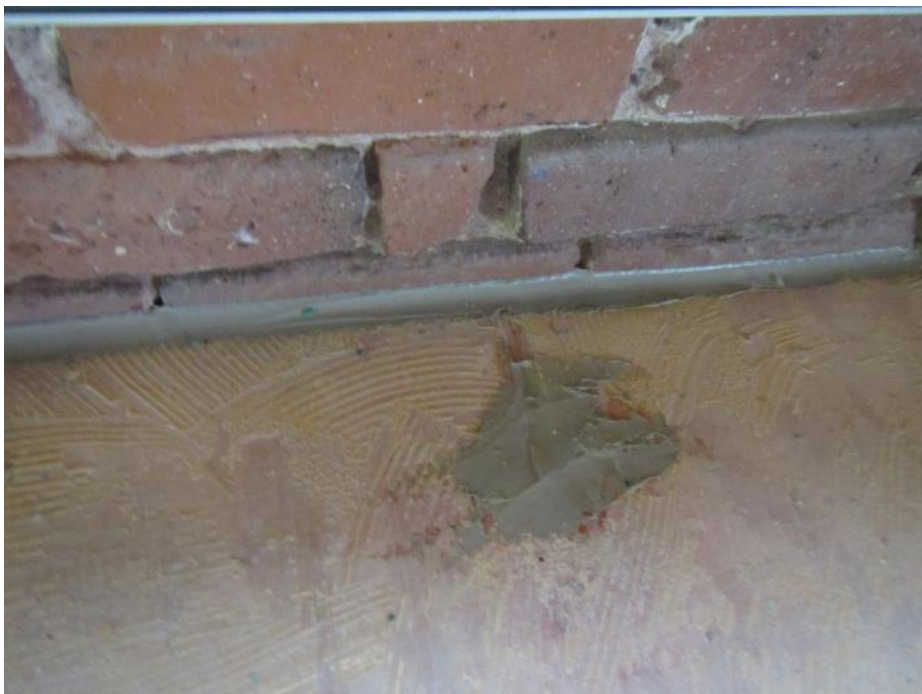
Picture 2

The fourth floor (above the BORIM space) was actively being renovated in the evening prior to this assessment. Many pathways between the BORIM-occupied space and the area under construction noted in the previous report were observed to be sealed (Picture 2).

Holes and seam along brick wall (pathways) have been sealed

2. Seal any remaining pathways between occupied and unoccupied/construction areas to prevent infiltration of dust and odors.
3. Cover BORIM workstations with plastic drop cloths in areas below active construction prior to evening renovations/demolition.

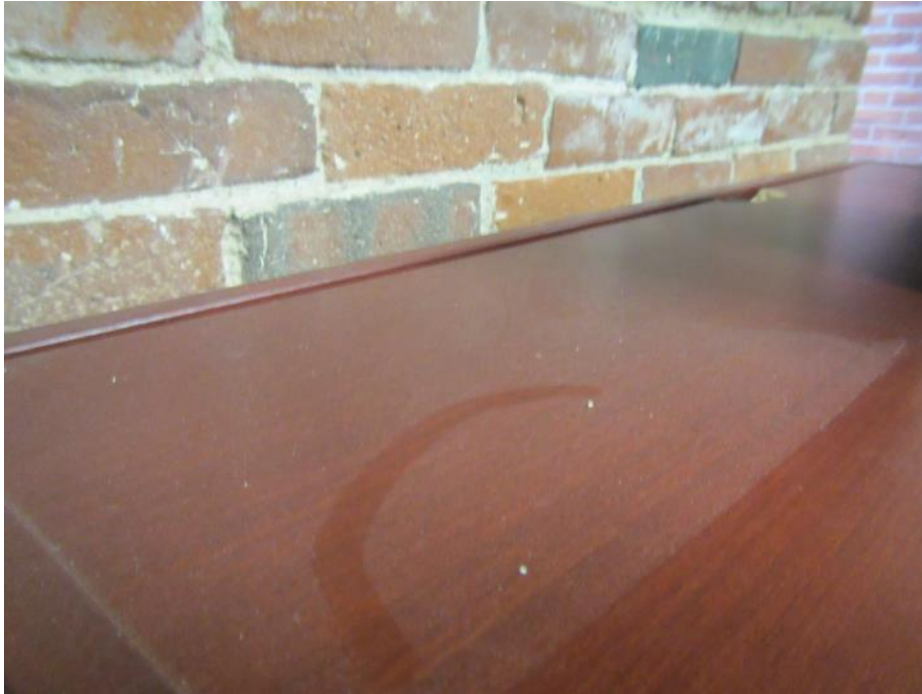
Picture 3

Some occupied areas in the BORIM space had a layer of dust on flat surfaces (Picture 3). This dust may or may not have been in place prior to the construction. However, flat surfaces should be thoroughly wet-wiped and floors vacuumed with a high efficiency particulate arrestance (HEPA) filter-equipped vacuum cleaner prior to occupants returning to work in the morning following construction activities.

Dust on flat surface in BORIM space

4. Occupants should keep workstations free from accumulated items so that custodial staff can have better access.
5. During the active construction project, perform daily wet wiping of surfaces and HEPA vacuuming of carpeting prior to occupants returning to work.
